Pipeline Group Factual Report

Stork Laboratory Report- LA-MS state line to HA joints burst test

**Carmichael, Mississippi
DCA 08 MP 001**

Examination of Dixie Pipeline 12-inch Hydrostatic Test Failures
Louisiana/Mississippi State Line to Hattiesburg 34-570

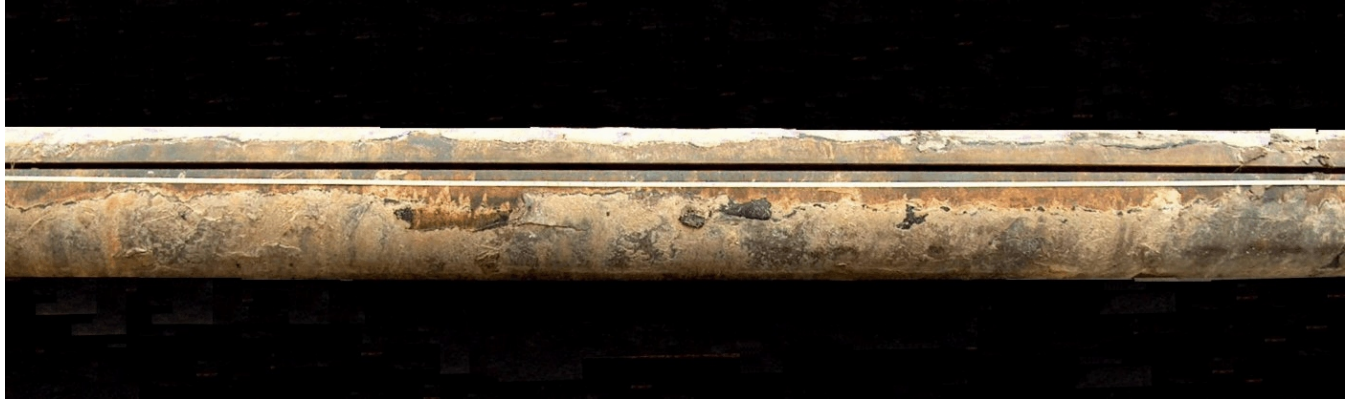
Pipe 1-2A had the longest rupture, 33 feet 3 inches. The fracture was flat and brittle for the full length with evidence of stitching on the outside surface, and what appeared to be dark oxides at the inside surface at several locations. Figure 1 shows part of the fracture, and Figure 2 is a close-up view of an area near the middle of the rupture with stitching and oxides.

Photograph of part of the rupture in Pipe 1-2A, showing the flat brittle fracture.

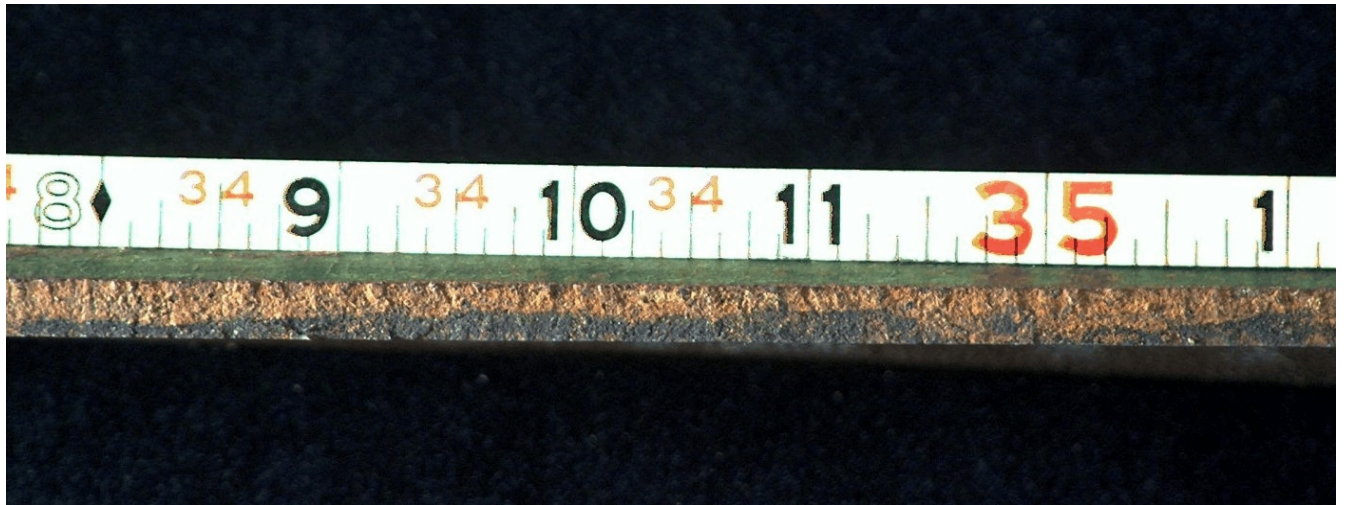
Figure 2

Close-up view showing evidence of stitching at the outside surface, and dark oxides along the inside surface of Pipe 1-2A.

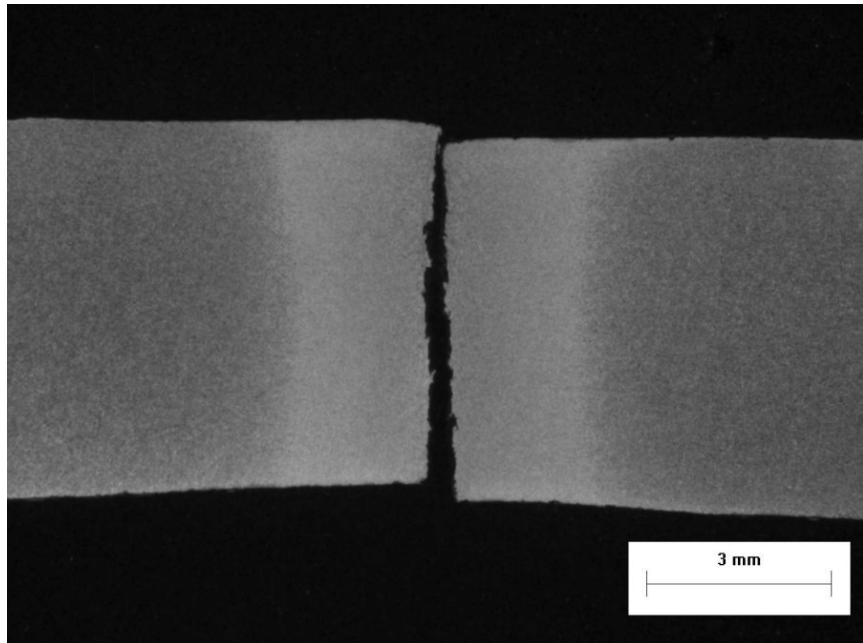
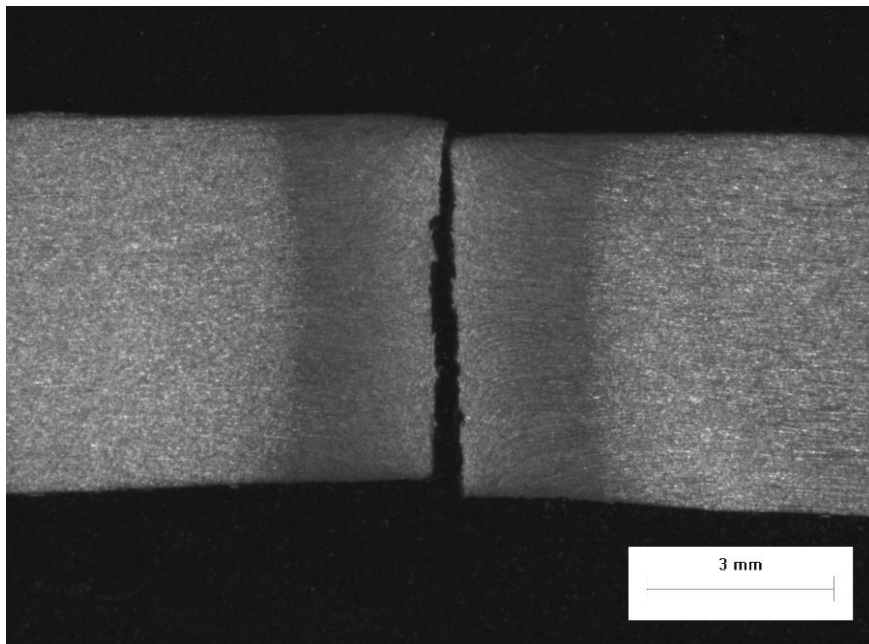
We took matching transverse sections from each side of the fracture at 35 feet 10-1/2 inches for metallographic examination. Figures 3 and 4 show the sections after polishing and etching. There was a broad weld HAZ, indicative of a low frequency electric-resistance weld. As discussed later, the presence of the HAZ is unusual in Lone Star Steel pipe. The fracture was along the weld line and appeared brittle.

Hardness surveys using a Vickers indenter and a 10-kgf load (HV 10) were made on the sections from Pipe 1-2A, shown in Figures 3 and 4, which had a distinct HAZ; and on the sections from Pipe 4-2B, which had no HAZ, for comparison. Four indentations spaced equally across the wall thickness starting 0.020 inch from the outside surface were made at three locations on each side of the fracture: in the base metal (BM) beyond the HAZ, in the middle of the HAZ, and as close as possible to the weld line (Weld). As shown in Table 3, there was no significant difference in the hardness of the two pipes.

Pipe 1-2A showed a clear HAZ, which is unexpected because Lone Star Steel has always full-body normalized electric-resistance welded pipe, which normally obliterates the weld HAZ. Many manufacturers did not post-weld heat treat electric-resistance welded pipe in the 1960s, and we considered the possibility that Pipe 1-2A was from another manufacturer. However, the chemical composition of Pipe 1-2A was very similar to the others. Of particular significance is the relatively high content of copper, and to a lesser extent chromium and nickel, for Grade X52 pipe, which indicates the pipe was made from electric-furnace steel with a high scrap content. Lone Star Steel was one of the few domestic manufacturers to use electric-furnace steel for line pipe in the 1960s. Pipe 3-2A also appeared to have a weld HAZ, although it was not as distinct as in Pipe 1-2A. The similarity of chemical compositions and appearance of a HAZ in two pipes suggests a malfunction in the post-weld heat treatment such that Pipe 1-2A was subjected to little or no heat, and Pipe 3-2A was heated, but not sufficiently to obliterate the weld HAZ.

Photomicrographs of the sections from Pipe 1-2A. Note the weld HAZ.

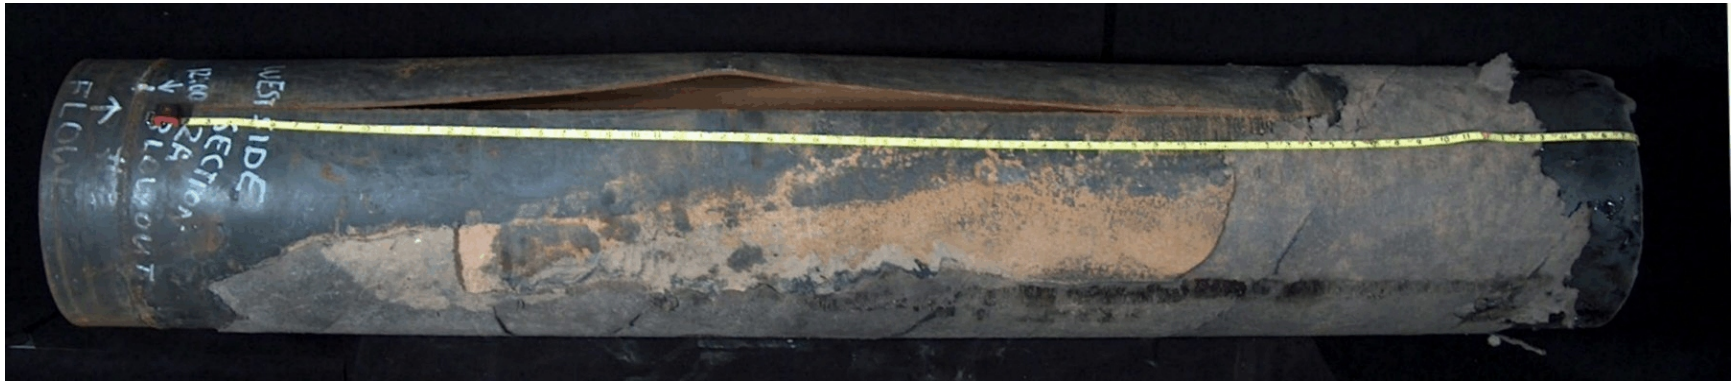
Figure 5 shows the rupture in 2-2A, which was 4 feet 4 inches long, with a bulge near the middle. There was a hook crack at the outside surface at the bulge, which was the apparent fracture origin. Figure 6 shows the fracture at the bulge with arrows indicating the hook crack. The dark material on the fracture is melted coating from torch cutting of the pipe.

Photograph of Pipe 2-2A.

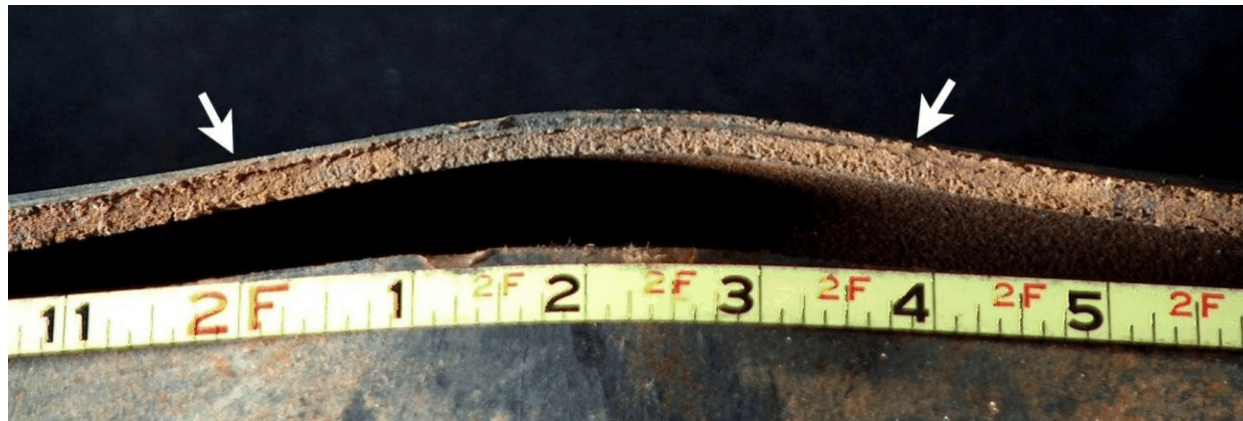
Figure 6

Close-up view of the apparent fracture origin, with arrows indicating a hook crack in Pipe2-2A.

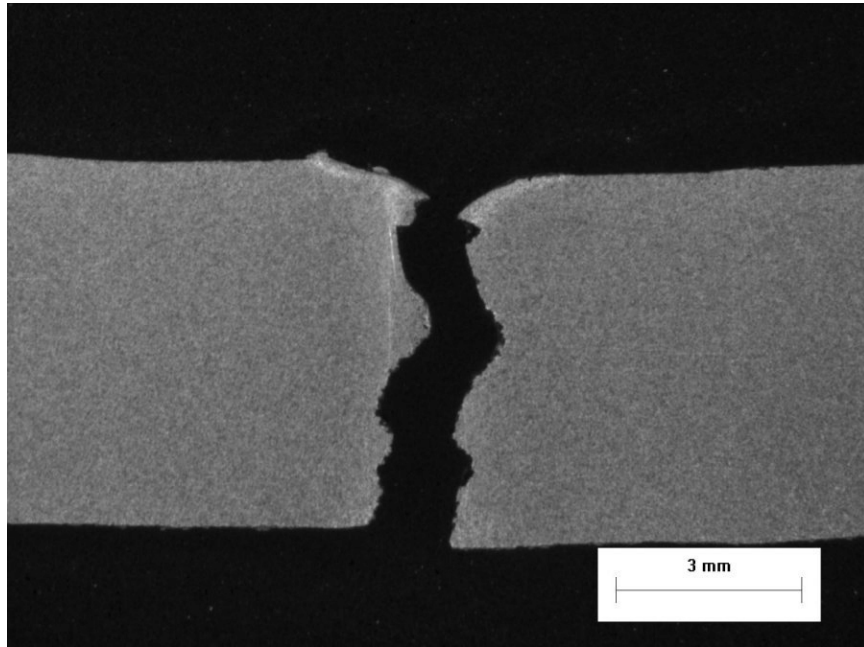
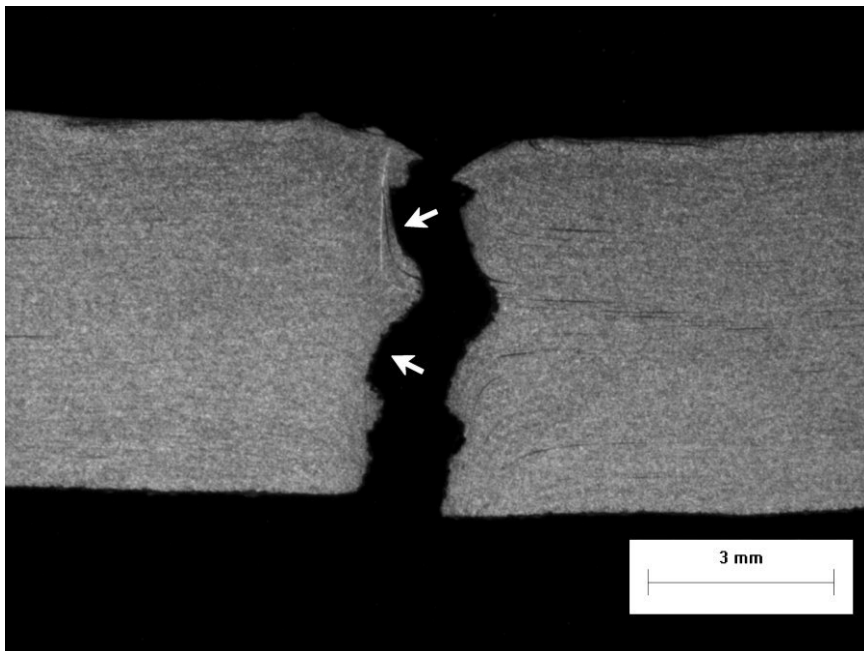
Matching transverse sections were taken from each side of the fracture at the middle of the rupture at 2 feet 2 inches, and Figures 7 and 8 show the sections after polishing and etching. There was post-failure mechanical damage on each side of the fracture at the outside surface, and two large hook cracks were apparent, as indicated by the arrows in Figure 8.

Photomicrographs of the sections from Pipe 2-2A, showing hook cracks, arrows, The outside surface was damaged after the rupture.

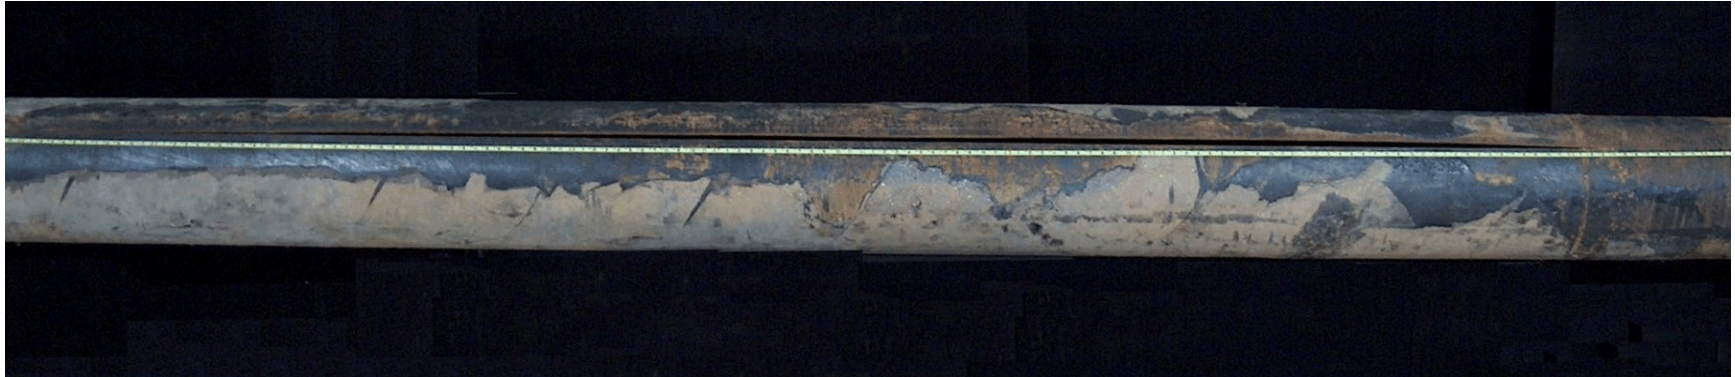
Figure 9 shows the rupture in 3-2A, which was 12 feet long in one joint and crossed

a circumferential weld at the downstream end for a length of three inches. There were no chevron patterns or bulge to indicate the fracture origin, but there was evidence of stitching along the outside surface for much of the length of the fracture. Figure 10 shows an area near the middle of the rupture with stitching.

Photograph of the rupture in 3-2A, which crossed the circumferential weld at the downstream end.

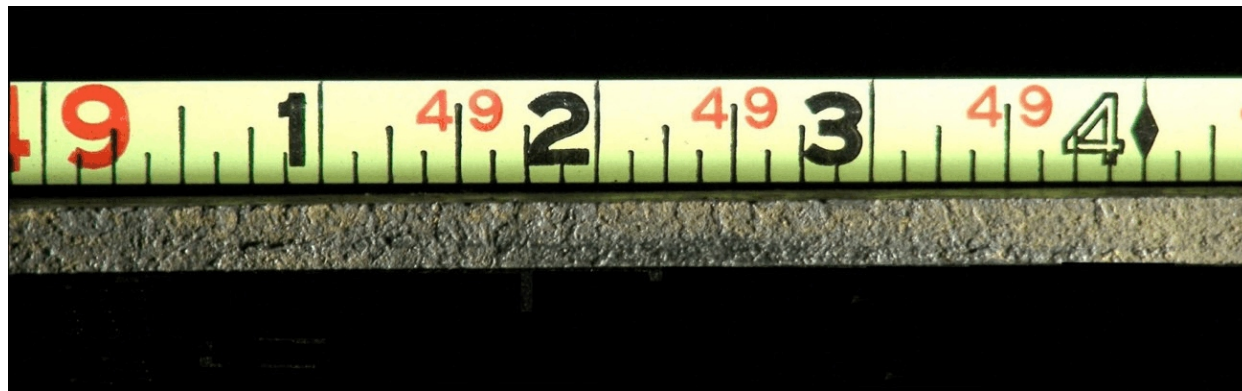
Figure 10

Close-up view at the middle of the rupture in Pipe 3-2A showing flat fracture with stitching along the outside surface.

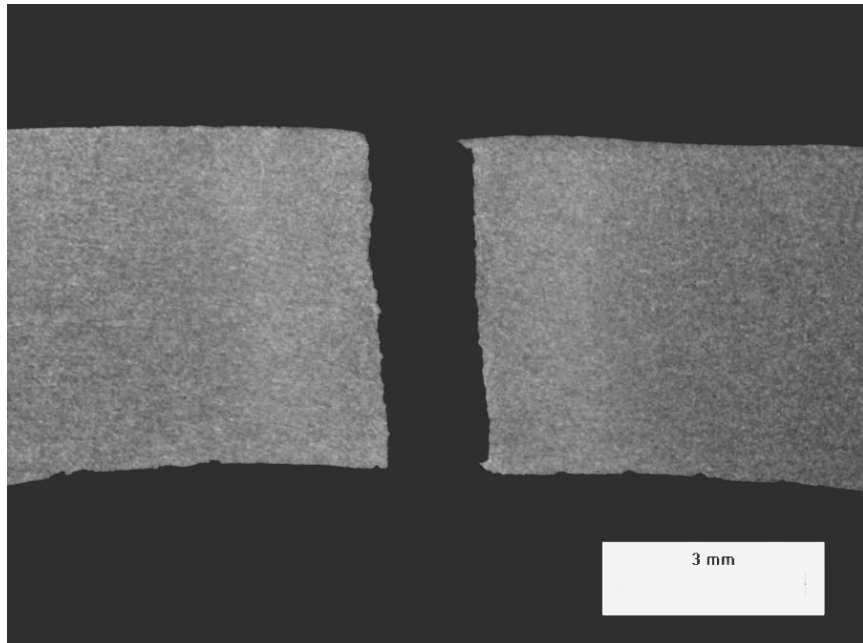
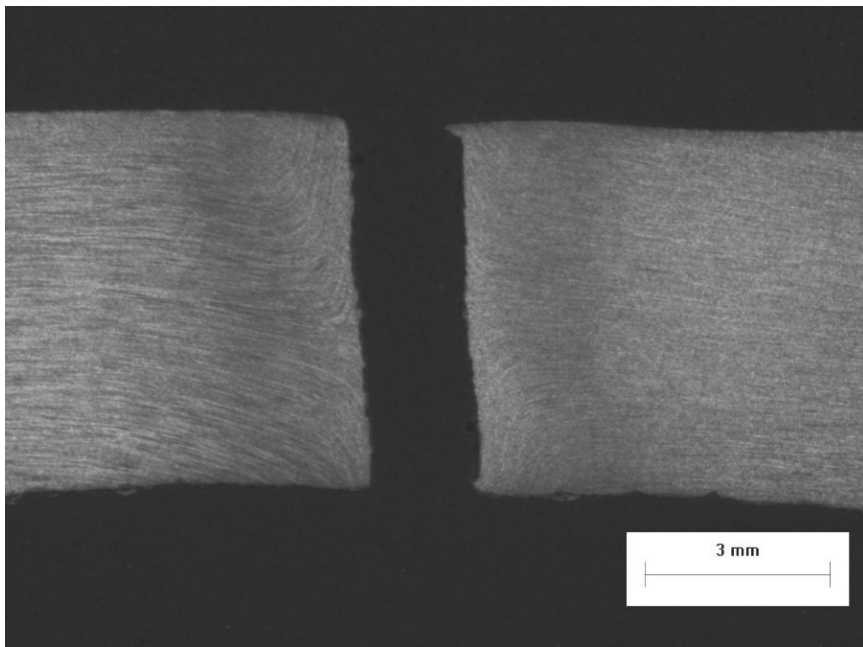
Matching transverse section were taken from each side of the fracture at 49 feet 2-1/2 inches for metallographic examination. Figures 11 and 12 show the sections after polishing and etching. The fracture was along the weld line, and there appeared to be a weld HAZ, although it was not as distinct as in Pipe 1-2A.

Photomicrographs of the sections from Pipe 3-2A, showing fracture along the weld line.

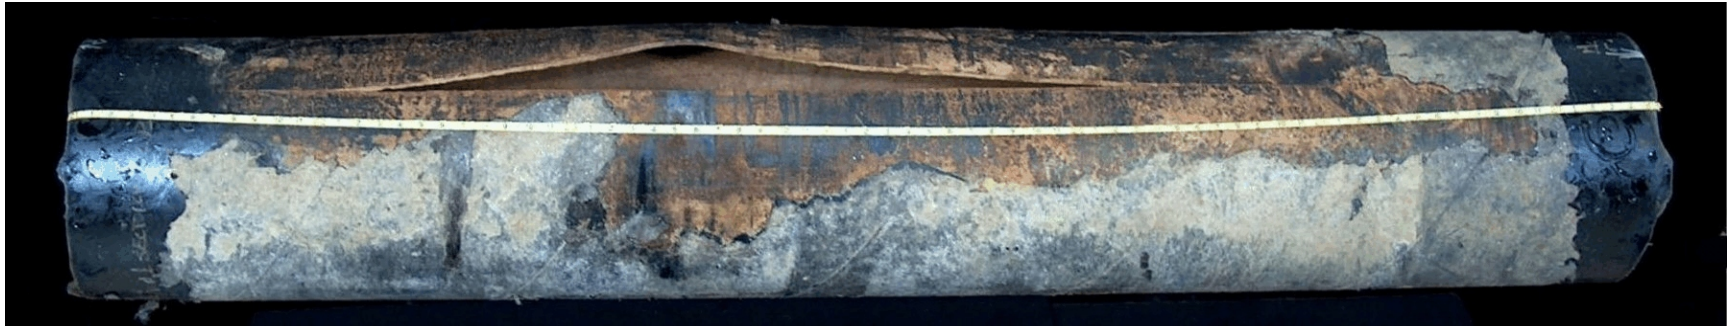
Figure 13

Pipe 1-2B ruptured for a length of four feet, with a bulge near the middle of the rupture, as shown in Figure 13. At the outside surface, there were small deposits of coating on the fracture and evidence of a hook crack at the middle of the bulge, as shown in figure 14.

Photograph of Pipe 1-2B.

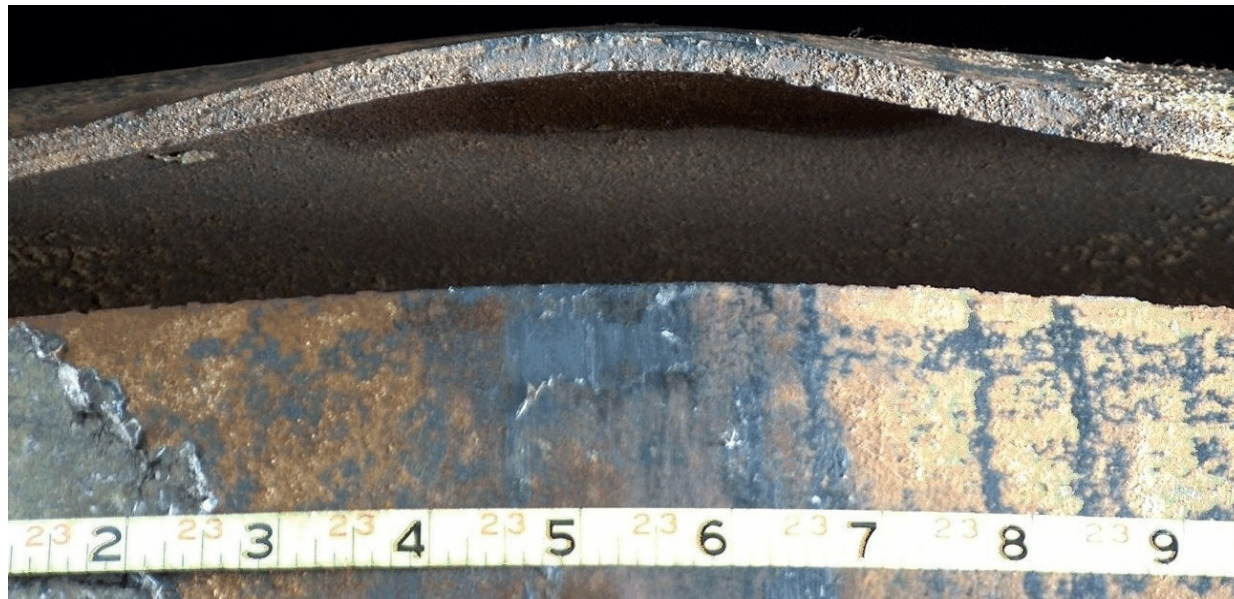
Figure 14

Close-up view of the bulge showing coating on the fracture at the outside surface of Pipe 1-2B.

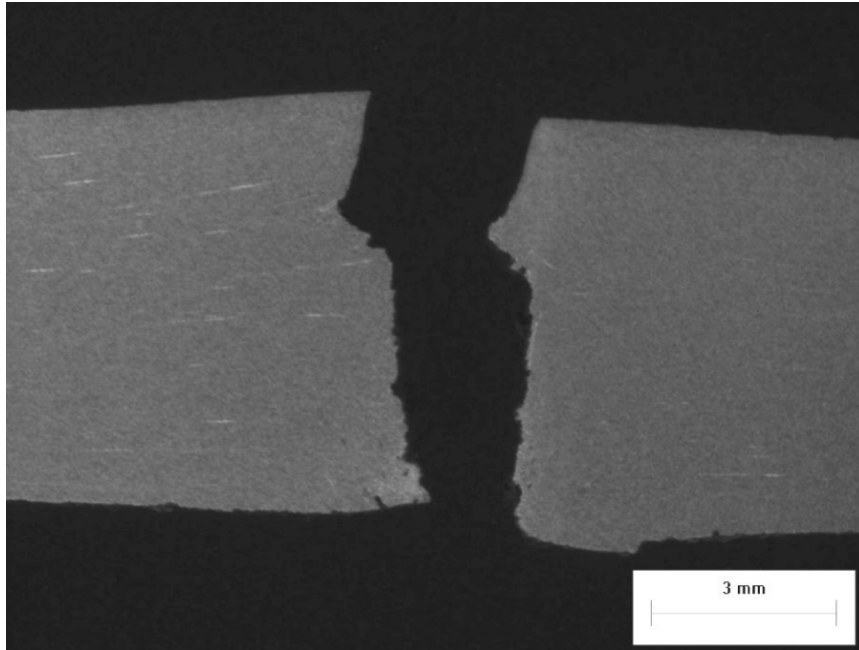
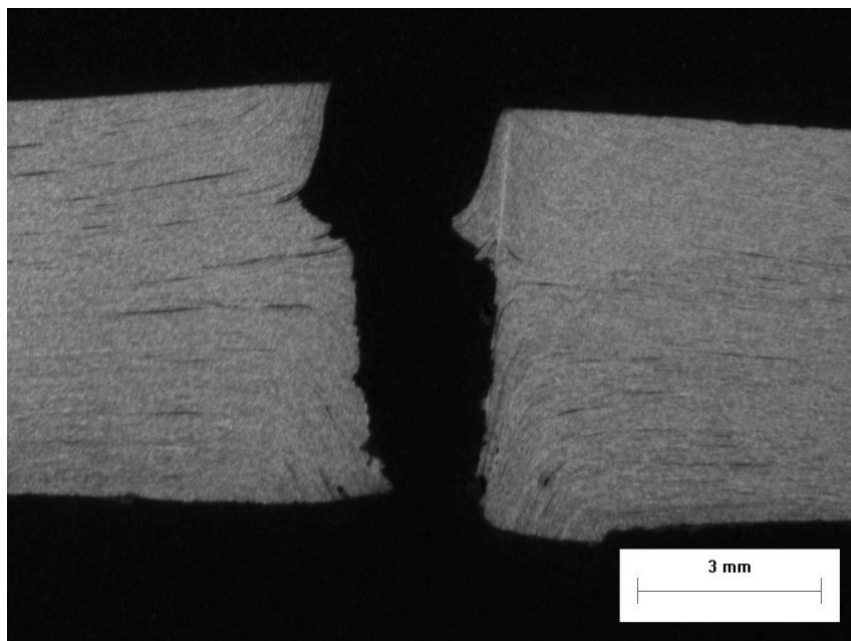
We took matching transverse sections at 23 feet 5-1/2 inches for metallographic examination. As shown in Figures 15 and 16, there was a large hook crack at the outside surface, with fracture along the weld line below the hook crack.

Photomicrographs of the sections from Pipe 1-2B, showing a large hook crack at the outside surface.

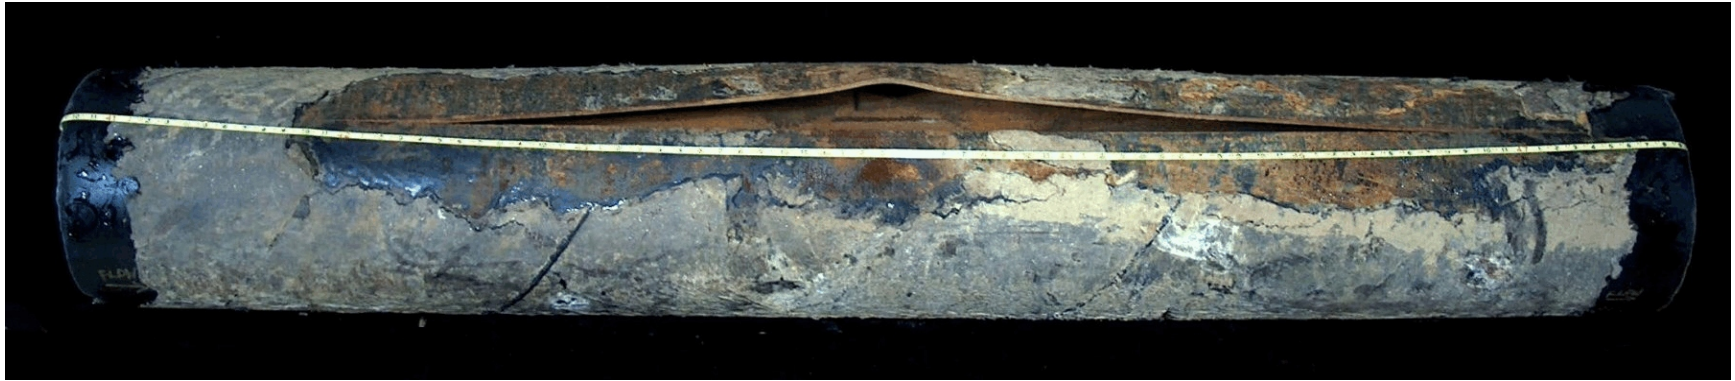
Figure 17

The rupture in 2-2B, shown in Figure 17, was 5 feet 6 inches long and appeared similar to the rupture in 1-2B except that there was no coating on the fracture surface. There were no chevrons, nor indications of hook cracks or oxides. There was evidence of stitching, and the fracture at the middle of the bulge was very flat and brittle, as shown in Figure 18.

Photograph of Pipe 2-2B.

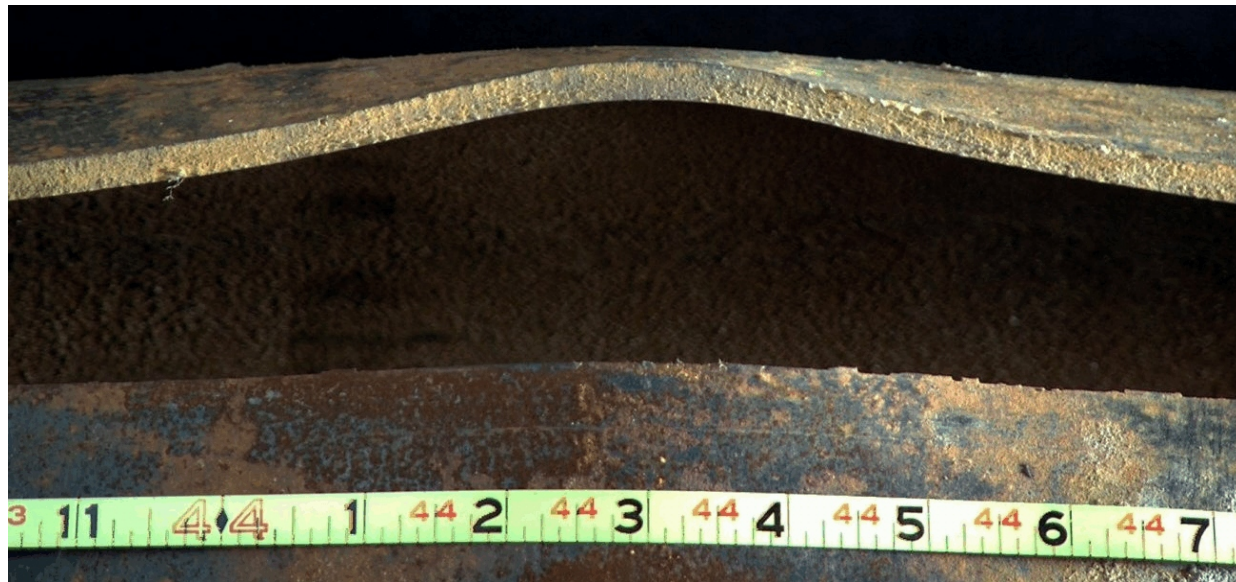
Figure 18

Close-up view showing the fracture at the middle of the bulge in Pipe 2-2B.

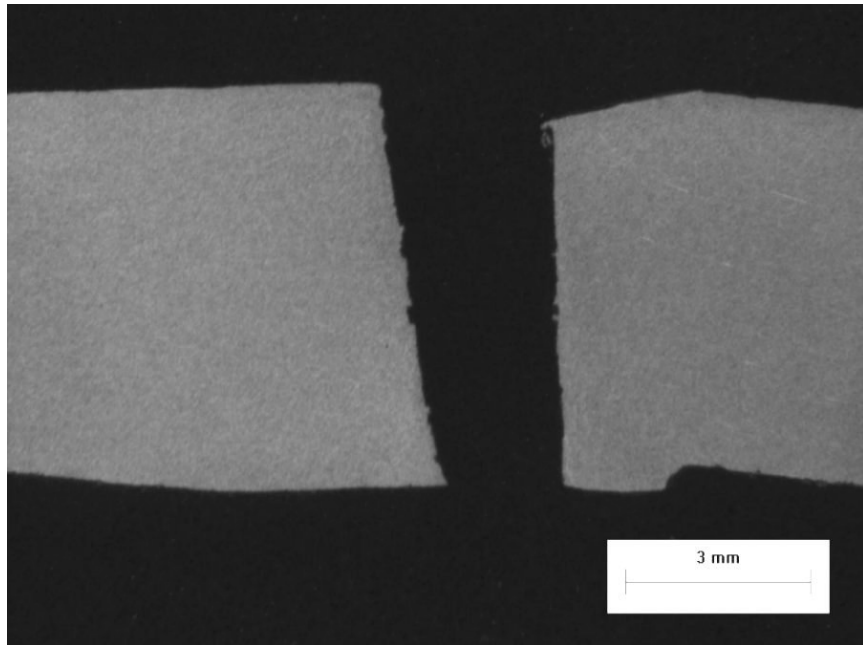
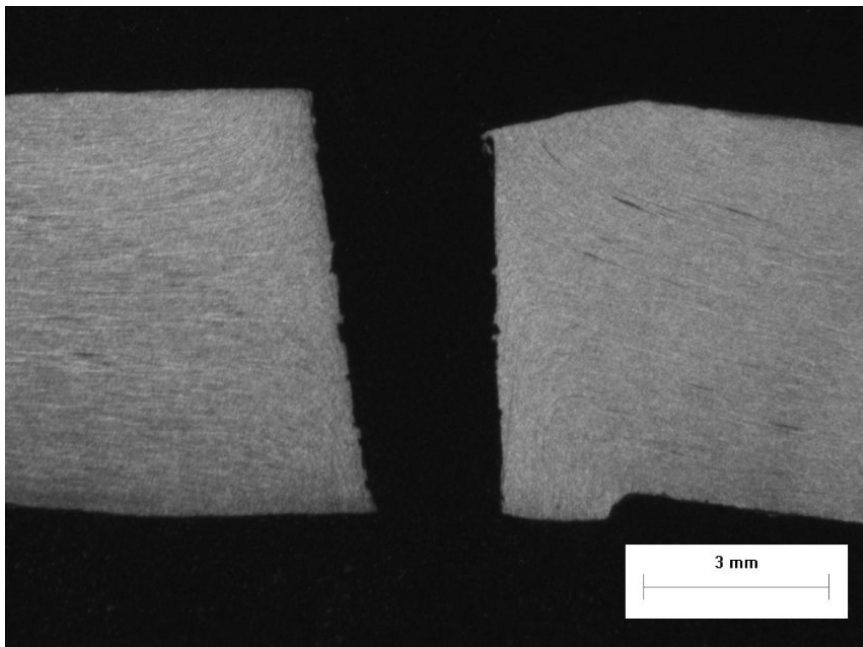
We took matching sections from the middle of the bulge at 35 feet 1/2 inch, which are shown in Figures 19 and 20 after polishing and etching. The fracture was along the weld line, and there was mechanical damage at the outside surface on one side of the fracture. There was a slight mismatch of the skelp edges (high-low), as indicated by the un-trimmed flash at right.

Photomicrographs of the sections from Pipe 2-2B, showing fracture along the weld line, and post-failure mechanical damage at the outside surface at right.

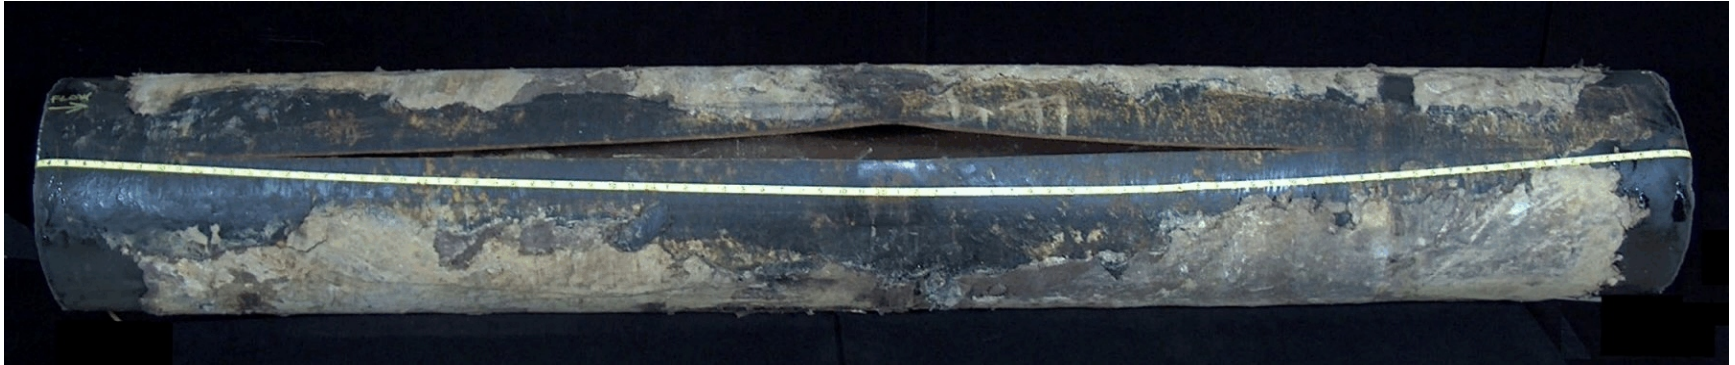
Pipe 3-2B ruptured for a length of 4 feet, with a bulge in the middle, and no other

indication of the fracture origin. Figure 21 shows the ruptured pipe, and Figure 22 is a close-up view of the fracture at the rupture. The fracture surface appeared brittle, but there was no evidence of stitching or oxides.

Photograph of Pipe 3-2B.

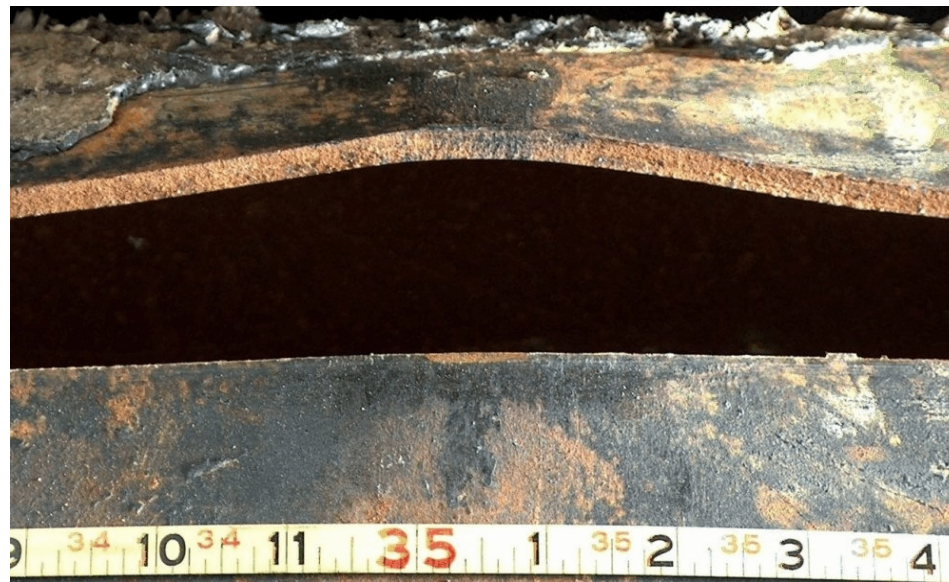
Figure 22

One failure, in Pipe 3-2B showed no stitching, but the weld was flat and brittle, and also appeared to be a cold weld. In addition to stitching, cold welds result from any variation in welding conditions that cause insufficient heat or pressure to make a sound weld.

Close-up view showing the fracture at the middle of the bulge in Pipe 3-2B.

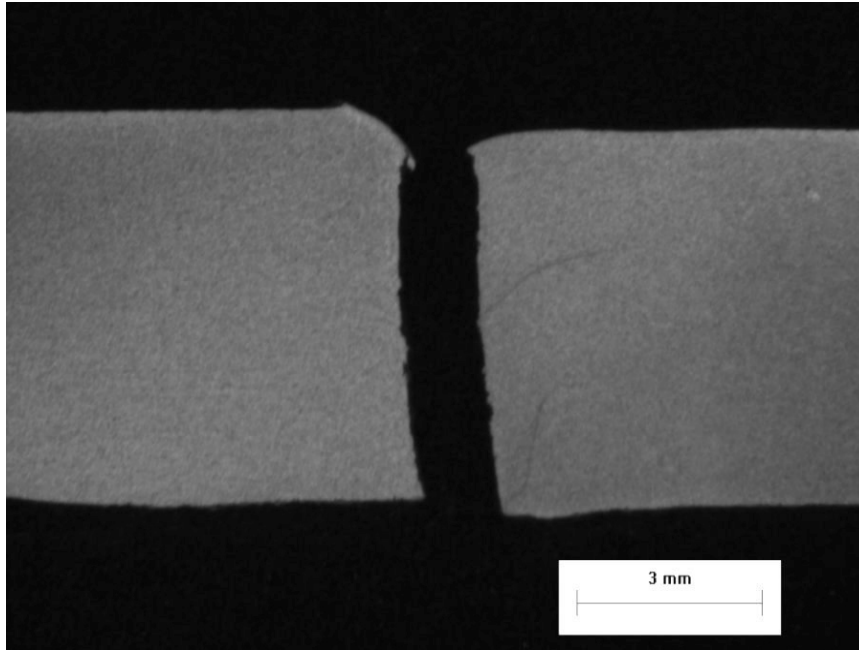
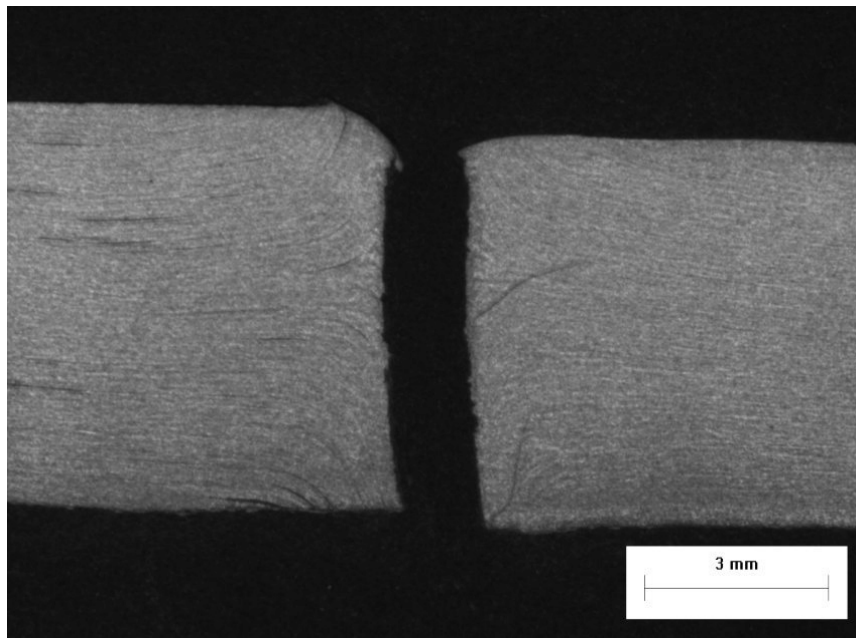
Matching sections were taken from the middle of the rupture at 35 feet 1 inch, and are shown in Figures 23 and 24 after polishing and etching. The fracture was along the weld line, and there was mechanical damage at the outside surface.

Photomicrographs of the section from Pipe 3-2B, showing fracture along the weld line, and post-failure mechanical damage at the outside surface at left.

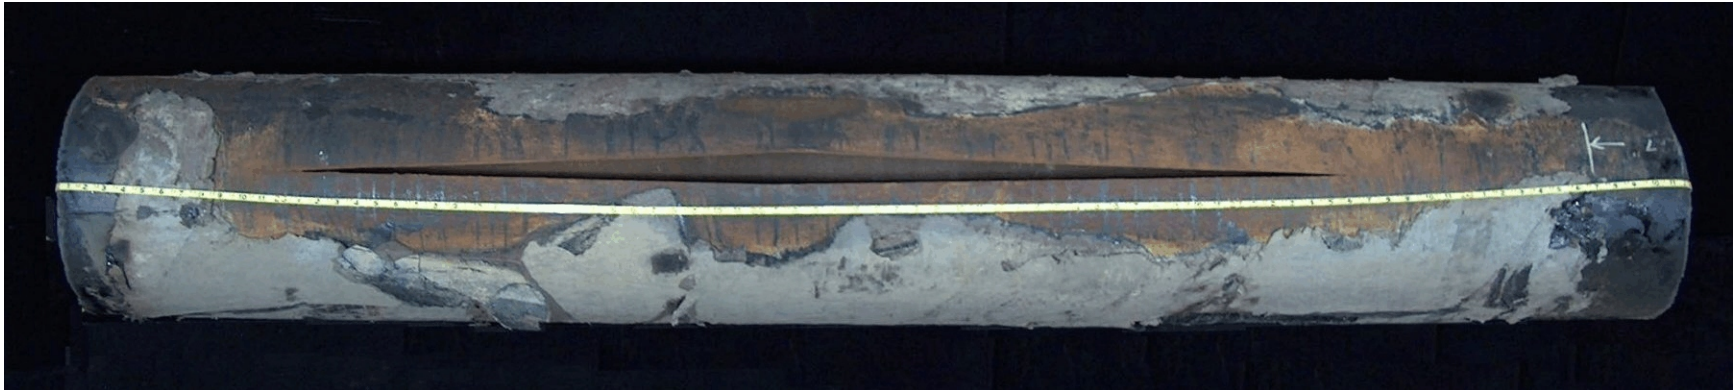
Figure 25

Pipe 4-2B, shown in Figure 25, ruptured for a length of 4 feet, with a bulge in the middle, and evidence of coating and weld flaws at the middle of the bulge. Figure 26 is a close-up view of the fracture at the bulge with arrows indicating the coating and flaws.

Photograph of Pipe 4-2B.

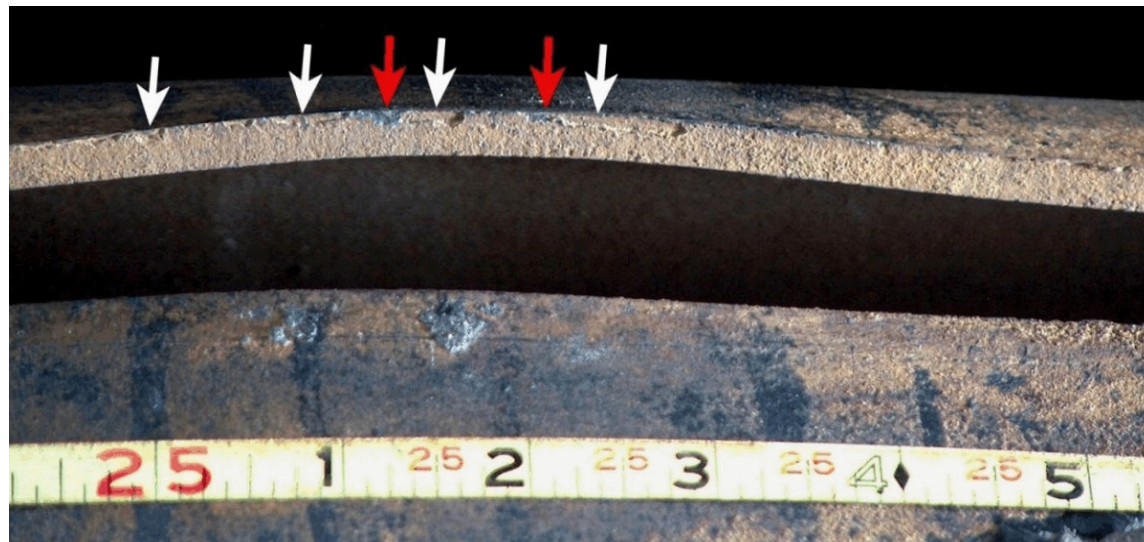
Figure 26

Close-up view showing small spots of coating, red arrows, and apparent weld flaws, white arrows along the fracture.

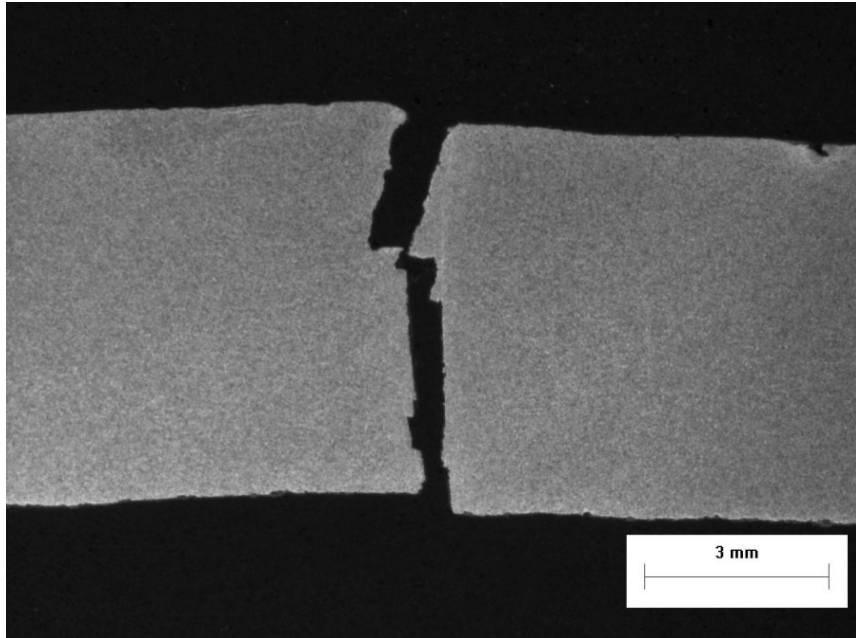
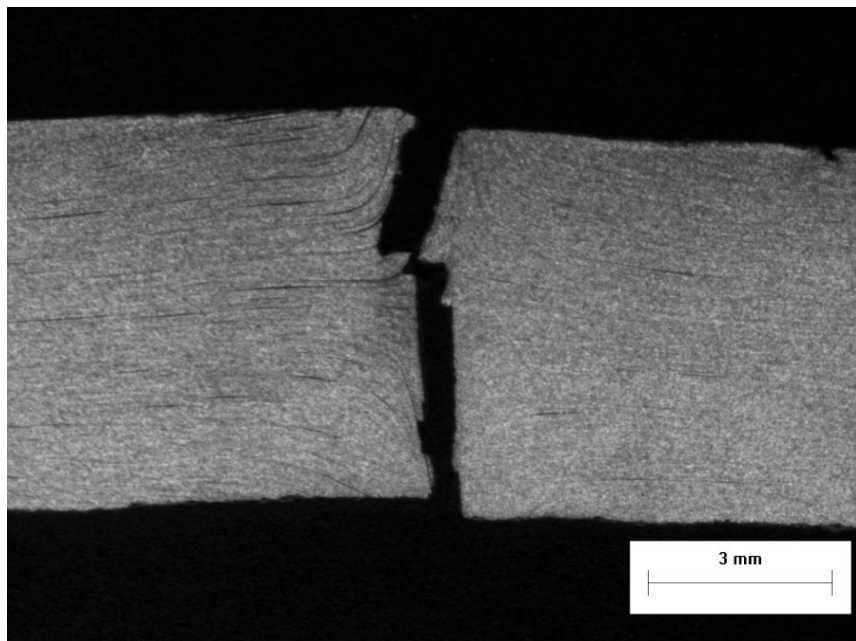
Matching sections were taken from the flaw at 25 feet 2-1/2 inches, indicated by the arrow at right in Figure 26, and are shown after polishing and etching in Figures 27 and 28. There was a large hook crack at the outside surface, and most of the fracture below the hook crack was along the weld line.

Photomicrographs of the sections from Pipe 4-2B, showing a large hook crack at the outside surface.
